Manhole Inspection Summary

Manhole # S37O__005MH

Insp Date: **1/23/08 1:59 PM**

Location Address: **william st**

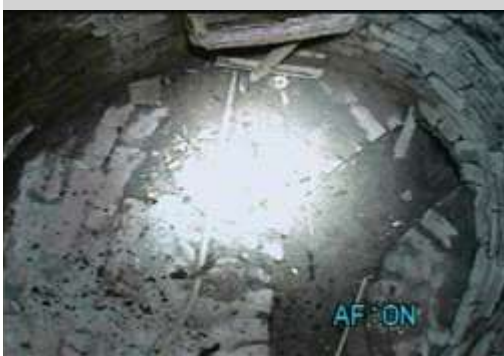
Defect 2

channel debris

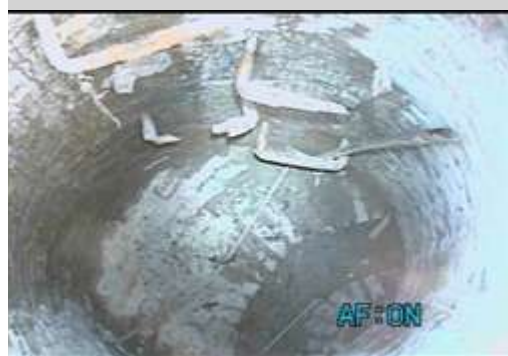
Defect 1

Count: **4** Missing: **2** ☒ **Corroded**

corroded steps

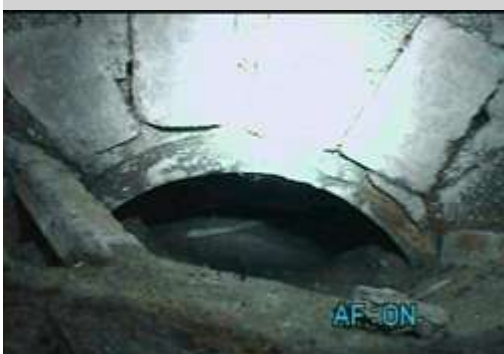
Defect 3

blocked pipe

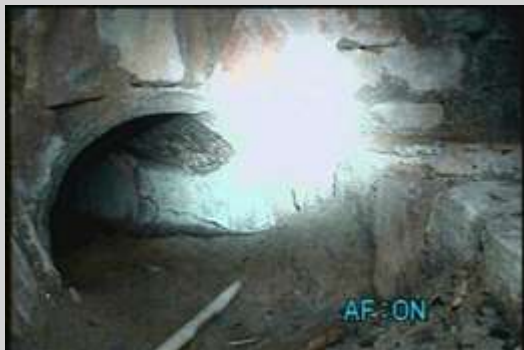
12 O'Clock Outflow

Deposits: ☐ None ☐ Mud ☐ Sludge ☒ **Debris** ☐ Grease

Silt Depth: 2 (in.) Deposits Extent: **Medium**

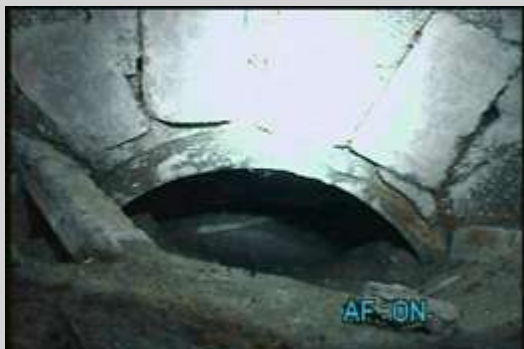
9 O'Clock Inflow

Deposits: ☐ None ☐ Mud ☐ Sludge ☒ **Debris** ☐ Grease

Silt Depth: 5 (in.) Deposits Extent: **Heavy**
